AVIATION INVESTIGATION REPORT
A01H0003

ENGINE POWER LOSS - FORCED LANDING

HORIZON AEROSPORTS (1982) LTD.
PILATUS PC-6T C-GROO
ABBOTSFORD, BRITISH COLUMBIA
22 JULY 2001

Report Number A01H0003

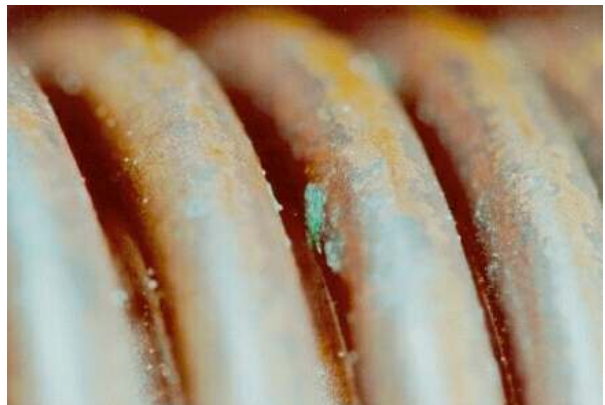
Figure 1. Bellows Corrosion

atmospheric-corrected height 1.0952 inches. This represented a difference in the bellows length of 0.0796 inches, which was much greater than the 0.007 inches allowed. The increased length was indicative of a loss of vacuum in the acceleration bellows. Also, there were a few portions of the bellows with very small patches of greenish-blue discolorations. These discoloured patches could be seen with the naked eye (see Figure 1). Thus, further technical investigation was carried out on the bellows.

At the time of the testing, the presence of greenish blue coloured corrosion deposits was noted. Besides the deposit at the location of the leak, a second major deposit of the same corrosion product was noted on the side wall of the third convolution. Because of the location of the leak, it was difficult to examine the site using scanning electron microscope (SEM) images. Figure 3 shows a possible corrosion pit coincident with a region relatively clear of corrosion product deposits. The pit was measured to be some 50 microns or approximately 0.002 inches in diameter and it appeared from the SEM images to have significant depth. The presence of other pits

underneath the heavier corrosion product deposits was considered a strong possibility. Energy dispersive X-ray analysis of the corrosion deposits indicated copper base corrosion products with a strong chloride and lesser sulphur presence. Both copper chloride and sulphate have the characteristic greenish-blue colour observed from the visual examinations and would be typically formed in the exposure of copper to moist marine or industrial atmospheres.

- Failure of the acceleration bellows assembly by loss of the contained vacuum resulted from a perforation of the outer of the two plies by corrosion pitting. Atmospheric air containing water vapour in the presence of chlorine or sulphur bearing gases was indicated by the characteristic composition of the corrosion products coincident with the leak site.

- The perforation of the outer wall allowed air to pass between the double plies and enter the evacuated interior airspace through voids and pores in the braze joint at the threaded end of the bellows assembly.
- No deficiencies in the materials of construction of the bellows assembly were considered contributory to the failure.

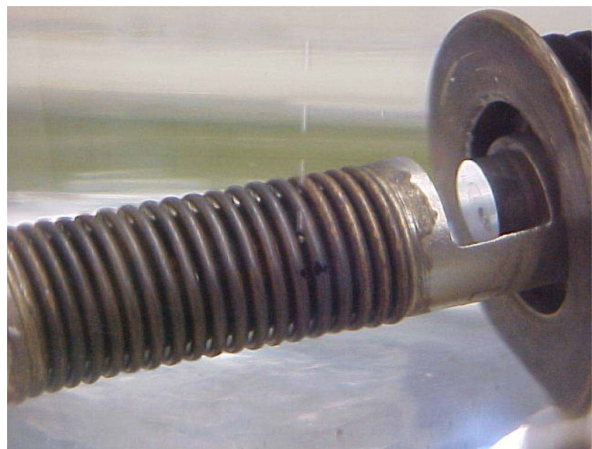
Figure 2. Bellows Leak Testing

The leakage of air shown by a stream of air bubbles is shown in Figure 2. The apparent site of the leak was identified as the side wall of the fifth convolution from the anvil end of the bellows. The location of the leak was at an area coincident with a corrosion deposit. It was decided that the examination of the failed bellows would be undertaken by the TSB Engineering Branch Laboratory. Examination was completed with representatives from the FCU manufacturer and Transport Canada, Continuing Airworthiness Directorate, in attendance.

The bellows are a double-wall design, and perforation of the outer ply should not have necessarily compromised the integrity of the contained vacuum. However, an examination of the braze joints at either end of the bellows suggested a possible leakage path, with the joint at the threaded end of the bellows being the more likely area. The interior of the sectioned bellows shows a deep depression in the braze adjacent to the inner ply. A corresponding microsection of this region showed an inadequate fill, extensive porosity, and all likelihood of a leakage path from the airspace between the plies and the normally evacuated interior of the bellows. The porosity, according to the manufacturer's representative, may have resulted from the thermal expansion of air contained between the plies being forced through the molten braze metal during the brazing operation.
